SUBJECT: ELECTRONIC TYPEWRITER DIAGNOSTIC TOOL (XTDT)

SUBJECT: YOKE BREAKAGE — RIBBON CASSETTE CARRIER

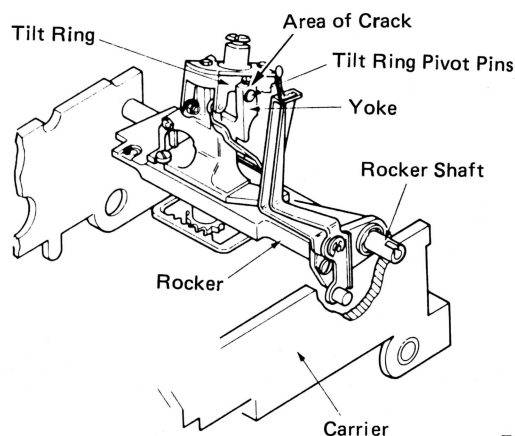
Figure 1

Poor print quality, especially of the underscore, may be caused by a crack in the yoke near the tilt ring pivot pins. (Figure 1)

If the yoke is found to be cracked, replace the rocker asm. (2-450: Part Number 1440310) rather than the carrier asm. A method of removing the rocker is as follows:

1. Remove cardholder bracket asm. (2-493).
2. Disconnect shift mode switch (3-309).
3. Loosen the rocker pivot shaft retaining screws (2-6, 2-404).
4. Remove rocker pivot shaft retaining "C"-clip (2-274).
5. Remove rocker return spring (2-313).
6. Slide rocker pivot shaft to the left until the shaft is out of the rocker asm. (2-272). [Holding the thrust washer (2-271)].
7. Remove the rocker asm. (2-450).
8. Install new rocker asm., reverse steps 1-6.
9. Check all related selection adjustments.

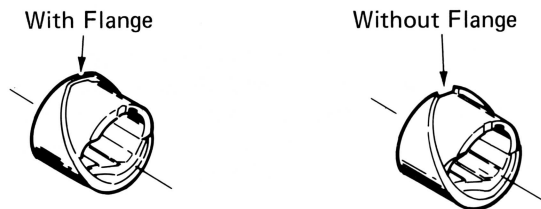
Figure 1

Some Ribbon Cassette System machines contain tape lift and feed cams (02-498) without a flange on the low dwell of the tape lift camming surface (Figure 1). A missing flange does not affect tape lift and will not cause correcting tape lift failures.

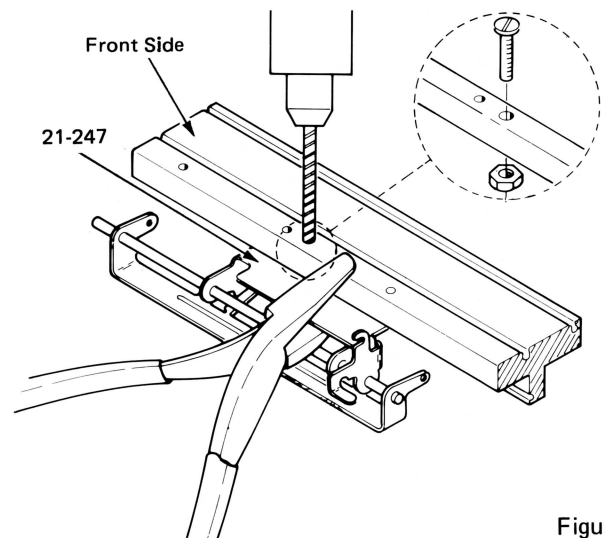
Figure 1

If the keyboard bellcrank mounting bracket screw (21-249) breaks and the remaining part of the screw cannot be removed, use the following procedure. Remove the keyboard assembly (21-264, 265) and drill a hole (Fig. 1) through the frame (08-16) and the bracket (21-247) alongside the existing screw, using a #29 drill bit (P/N 0450163). Install a new screw (P/N 1164581) and a nut (P/N 1134842). The nut should be installed on the rear side of the frame.

NOTE: To facilitate the drilling, the frame and the bracket may be held together with duck bill pliers.

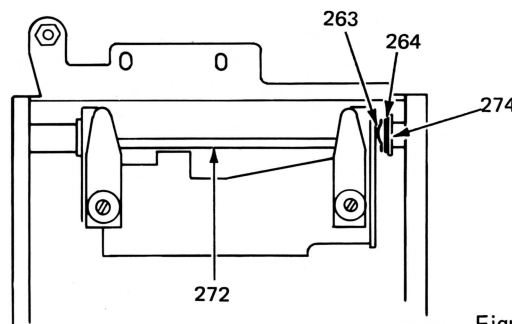
Figure 1

When experiencing inconsistent print quality and/or voids in low velocity repeat characters and all print adjustments are correct (particularly velocity cam follower clearance), install the compression washer B/M (02-270). Lubricate the washers before assembly with a film of #23 grease.

Adjust the rocker shaft to compress the washer without causing an excessive bind. To do this, half cycle the print shaft and load the rocker shaft to the left with a minimum of 6 lbs. of force to compress the washer (a spring scale may be used). Then tighten the retaining screws (02-6, 404). While still half cycled check for binds by manually moving the rocker to the print position. The rocker must restore completely under tension of the restoring spring.

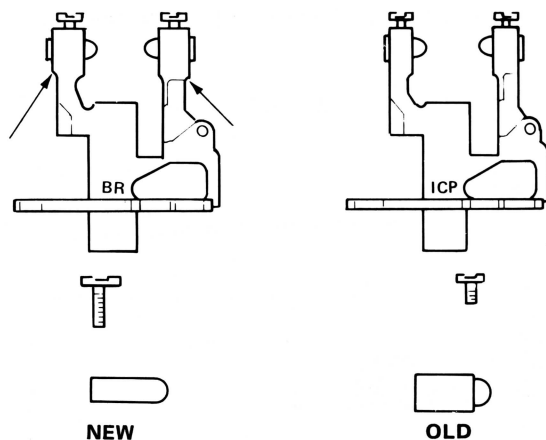
Figure 1

Carrier yokes (02-275/276) have been redesigned to prevent cracking around the tilt ring pin screw (02-269) hole. These yokes will have thicker uprights and use smaller diameter tilt ring pins (02-278) and longer tilt ring pin screws (02-269). See Figure 1.

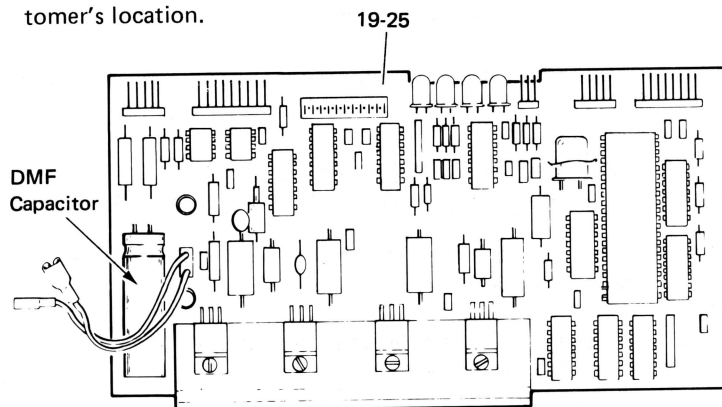
Figure 1

The escapement control board (19-025) uses a capacitor which contains a small amount of Dimethylformamide (DMF). (Figure 1) Under normal use the capacitor does not pose a health problem.

Precautions should be taken when a leaking or damaged capacitor is found. Polyethylene gloves (p/n 2200041) should be worn when handling a board with a leaking or damaged capacitor. A board with a leaking or damaged capacitor should be placed in a plastic bag (p/n 9900387) before handling further. Any spilled material should be cleaned up with a shop cloth. Gloves and rags may be disposed of at the customer's location.

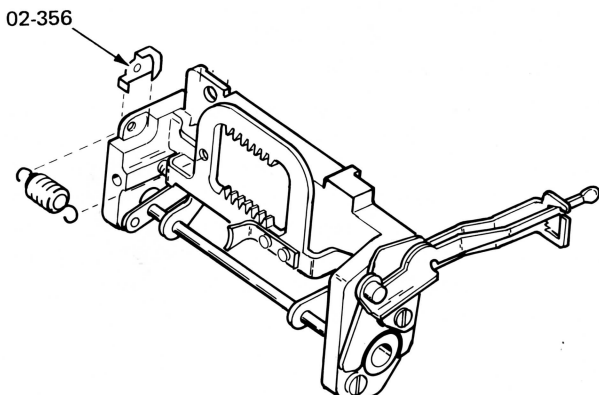
Figure 1

A wear prevention clip is now available to prevent the rack return spring (02-298) from wearing through the rocker casting (02-289). The clip also provides a new surface if the rocker casting is partially worn or completely worn through. The existing spring will be used with the clip.

Note: Squeezing the clip together slightly before installing will help hold it in place while remounting the spring (Fig. 1).

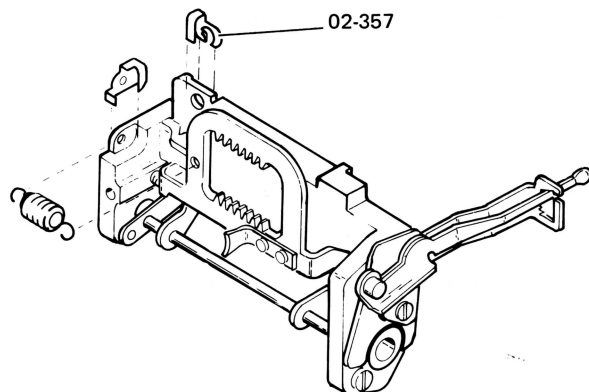
Figure 1

A wear prevention clip is now available to prevent the rocker return spring (02-313) from wearing through the rocker casting (02-289). The clip also provides a new surface if the rocker casting is partially worn or completely worn through. The existing spring will be used with the clip.

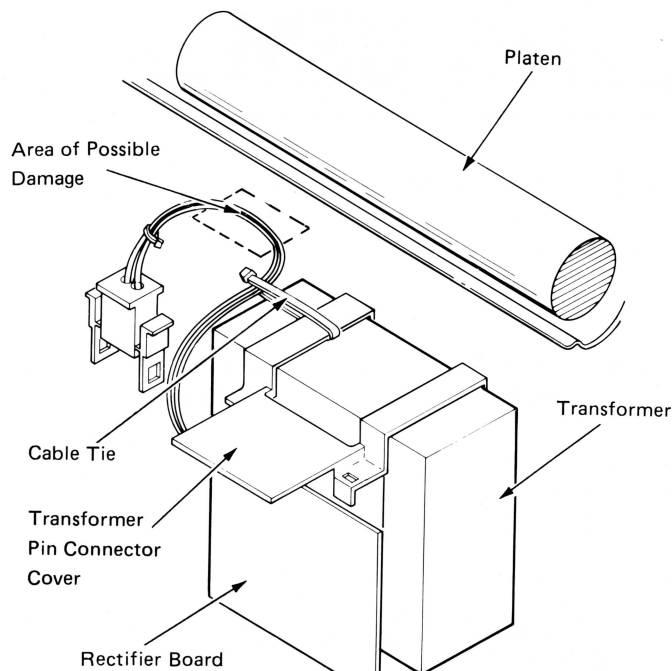
Figure 1

Transformer leads on affected machines may be positioned so that they are in the path of the carrier leadscrew nut. Insulation damage can occur to the primary power leads of the transformer, **exposing live voltage to the machine frame**. This involves the risk of electric shock.

Replace any transformer(s) with lead damage.

Install wire tie (29-03) between the transformer leads and the transformer pin connector cover (12-52) (see Figure 1) on **all** machines within the specified serial range to ensure adequate clearance between the transformer leads and the leadscrew nut. The cable tie is plantinstalled above the specified serial range.

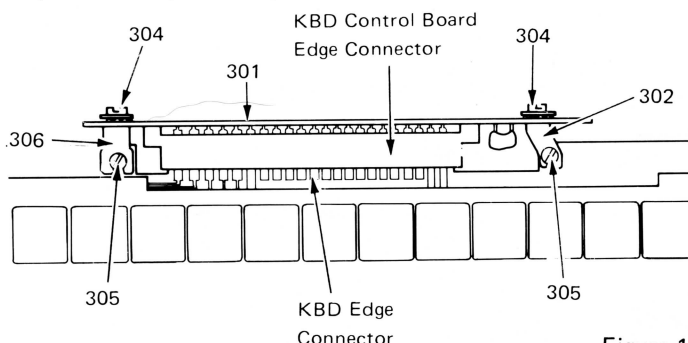
Figure 1

When a malfunctioning row or column of keybuttons is encountered, the problem may be caused by poor connection between the keyboard control board (21-301) and the keyboard (21-303). The following procedure can be used to correct this problem: Loosen keyboard logic clip mounting screws (21-305), disconnect keyboard control board (21-301) from keyboard and clean the keyboard edge connector (visible oxidation may be cleaned with an eraser). Loosen both keyboard logic mounting screws (21-304). When reinstalling the parts, tighten keyboard logic clip mounting screws (21-305), before tightening the keyboard logic mounting screws (21-304). This procedure will help eliminate any stressful condition between keyboard edge connector, keyboard logic mounting clips (21-302, 306) and keyboard control board. (Figure 1)

NOTE: Some early level keyboard logic mounting clips (21-302, 306) were shorter and affected the edge connector's reliability by forcing the top of the connector upwards, opening its contacts. If, when reconnecting, the keyboard control board edge connector and the keyboard edge connector cannot be aligned without downward pressure to the connector, replace the keyboard logic mounting clips.
